## CHARACTERIZATION OF DECAY IN THE WOODEN ROOF OF THE S. AGATA CHURCH OF RAGUSA IBLA (SOUTHEASTERN SICILY) BY MEANS OF SONIC TOMOGRAPHY AND RESISTOGRAPH PENETRATION TESTS

**KEY WORDS:** wood, sonic tomography, penetration test, S. Agata Church of Ragusa Ibla

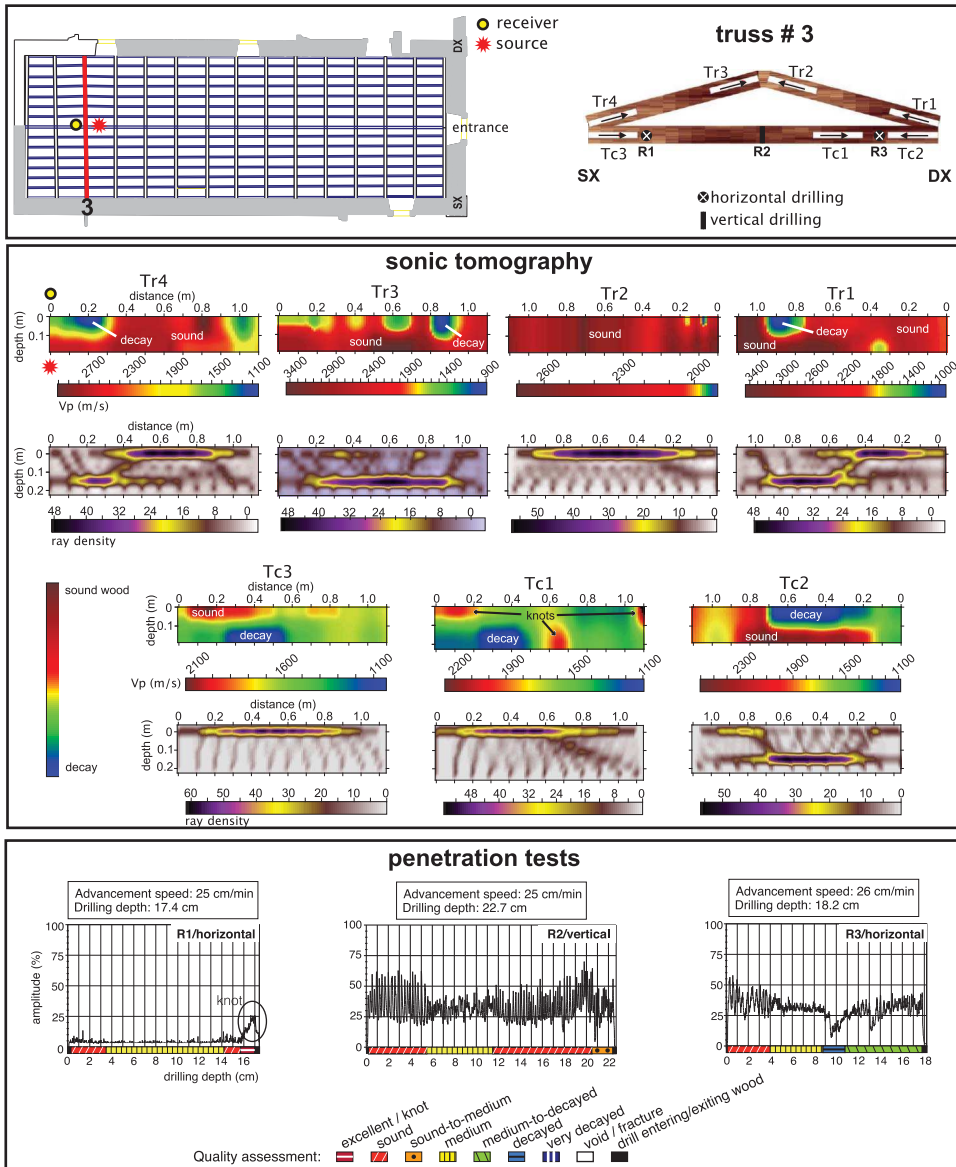
In the truss # 3 (Figure 4) sonic velocity ranges from 900 to 3,400 m/s along the rafters (Tr1-Tr4) and from 1,000 to 2,600 m/s along the chord (Tc1-Tc3), this last characterized by the largest low-velocity anomalies. In the rafters,  $V_p$  is predominantly higher than 2,000 m/s (red to brown), indicating the presence of sound wood, with sparse low velocity areas (blue) indicating the presence of decay in the first centimeters of depth. The high-velocity spots imaged in Tc1 are interpreted with the presence of knots.

Since the chord exhibited the worse mechanical conditions, penetration tests were performed on this element only. The drilling sensitivity level, tentatively chosen for a “hard” wood type in the first measurement R1, was set to a “soft” wood type in the remaining tests. R1 was drilled next to the right end of Tc3 that is characterized by intermediate  $V_p$  values. Consistently, this test displays a medium-quality wood for most of the path. The highest drilling resistance between 15.7 and 17.0 cm is due to the presence of a knot. The

**Figure 4.** Upper panel: (left) plan of the S. Agata Church; the truss under test is highlighted; the position of sources and receivers used for tomography following the configuration of Figure 2d is indicated; (right) truss outline with the position of penetration tests (circles indicate horizontal drillings, bars indicate vertical drillings) and tomography profiles (the rightward or leftward sense of acquisition is due to logistic reasons). Middle panel: sonic tomograms and corresponding ray density diagrams. Tomograms image horizontal slices of the timbers with the y-axis (depth) increasing toward the church’s entrance. They illustrate wood quality with graduated shading. Ray density diagrams indicate the number of rays sampling each cell of the velocity model. Lower panel: profiles of resistance to penetration vs. drilling depth. Patterned bars along the x-axis indicate wood quality. Depth varies between 16 and 24 cm depending on the thickness of the timber in the drilling direction. Horizontal tests are drilled toward the entrance of the church; vertical tests are drilled upwards. The resistogram R1 was obtained using a low drilling sensitivity, raised in the following tests (color figure available online).

test R2, drilled vertically in the middle of the chord, in a point that looked intact at the surface, confirmed the presence of a good-to-medium quality wood. In R3 wood quality is variable from sound to decayed.

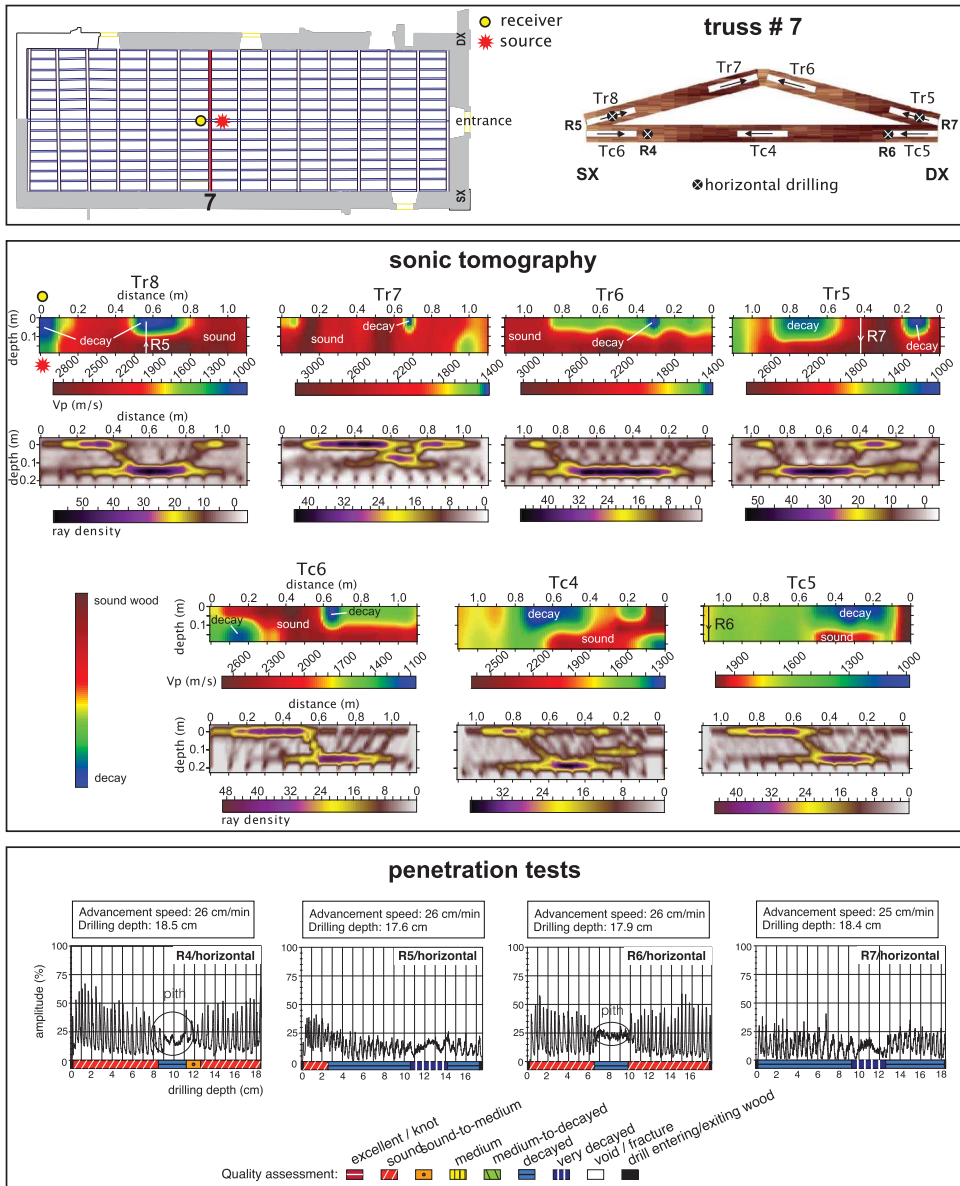
**Figure 5.** As in Figure 4, except that results refer to truss # 7. In the middle panel, lines crossing the tomograms along-depth indicate horizontal drillings (orientation is given by the arrow) (color figure available online).

In the truss # 7 sonic velocity is lower and deteriorations are larger in the chord than in the rafters (Figure 5), as in the truss # 3. Sound wood is drilled in the chord along R4 and R6, this last crossing the tomogram Tc5 in a point of almost absent ray coverage. R4 and R6 intersected the pith area between 8.5 and 11.2 cm and 6.5 and 9.8 cm, respectively. Pith

is a spongy tissue offering a lower resistance to drilling with respect to adjacent areas; for such reason this portion of R4 and R6 was assessed erroneously as “decayed wood” by the Resistograph.

R5 and R7 tested the rafters across the tomography profiles Tr8 and Tr5, respectively. R5 detected a wood quality variable from sound to decayed, in agreement with the velocity

imaged in Tr8; in contrast, the low amplitude displayed by R7 is not consistent with the high velocity values imaged in Tr5.

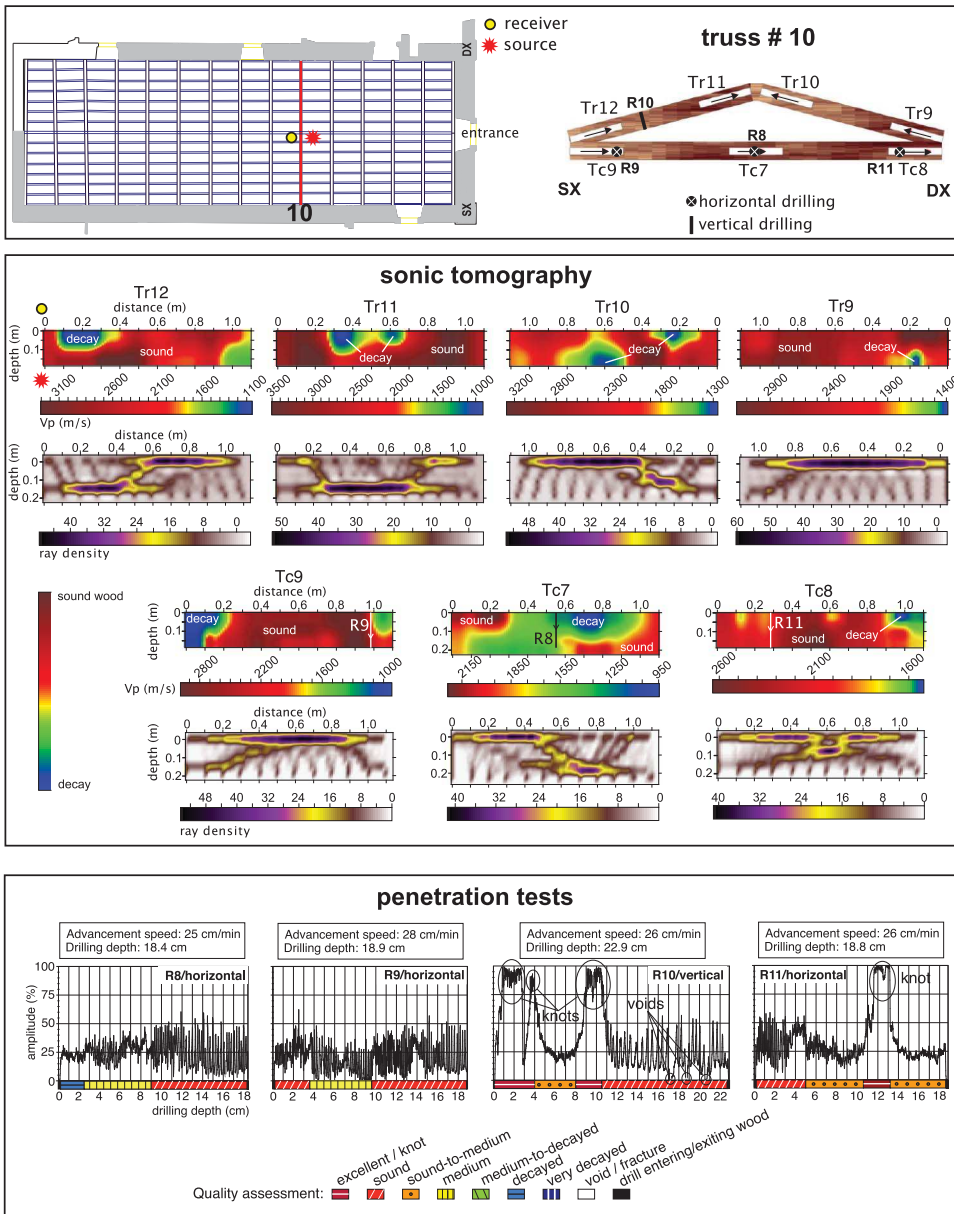
**Figure 6.** As in Figure 4, except that results refer to truss # 10. In the middle panel, lines crossing the tomograms along–depth indicate horizontal drillings (orientation is given by the arrow) (color figure available online).

The chord of the truss # 10 (Figure 6) has better mechanical conditions than trusses # 3 and 7, but velocity is still lower than in the rafters. Deteriorations are present at the ends of the chord (tomograms Tc8 and Tc9).

Penetration tests R8, R9 and R11 were drilled horizontally into the chord, crossing three tomography sections. Results are consistent: R9 and R11 detected good-quality wood across areas of high velocity in Tc9 and Tc8, respectively, while R8 detected a variable quality in the middle of the chord, as imaged in Tc7. The 1-cm knot drilled by R11 was not resolved in the tomography image. Across the left rafter, R10 drilled a good-quality wood with centimetric portions of maximum resistance to drillings (knots). Few micro-voids were picked out next to the upper side of the timber (at 17.0, 18.6, and 20.5 cm).

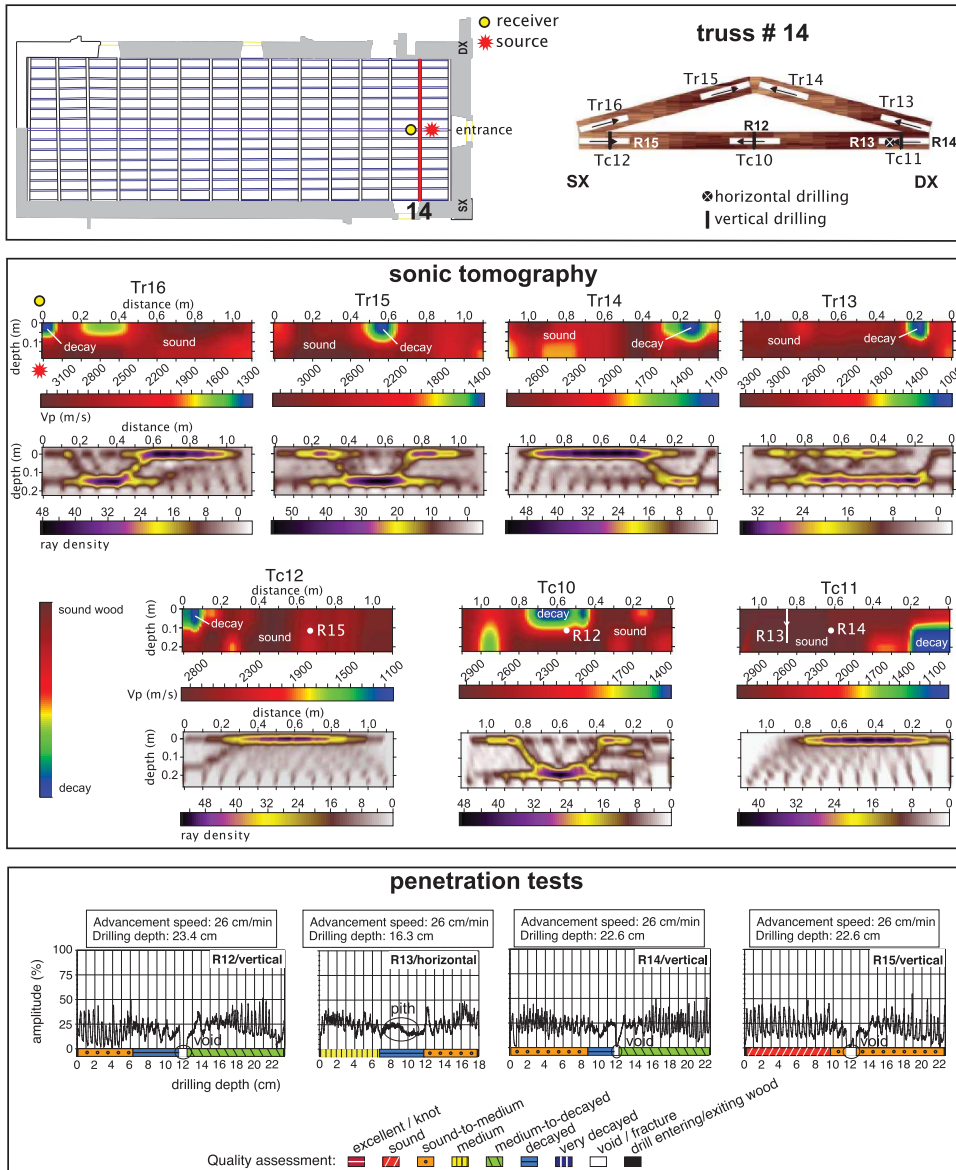
**Figure 7.** As in Figure 4, except that results refer to truss # 14. In the middle panel, lines crossing the tomograms along-depth indicate horizontal drillings (orientation is given by the arrow); circles indicate the position of vertical drillings (color figure available online).

Truss # 14 is mostly characterized by high velocity with small decayed areas in the upper 10 cm of the sections (Figure 7). The larger low-velocity anomaly imaged at the right end of the chord (Tc11) is poorly constrained. Three vertical drillings, equally spaced along the chord from one end to the other, detected a small cavity (few mm to 1 cm) at the same depth; this is suggestive of a linear continuous feature, possibly a microcrack, extending along the entire length of the timber.
