Geophysical surveys integrated with rainfall data analysis for the study of soil piping phenomena occurred in a densely urbanized area in eastern Sicily

Graziano Patti¹ · Sabrina Grassi¹ · Gabriele Morreale² · Mauro Corrao² · Sebastiano Imposa¹

Abstract

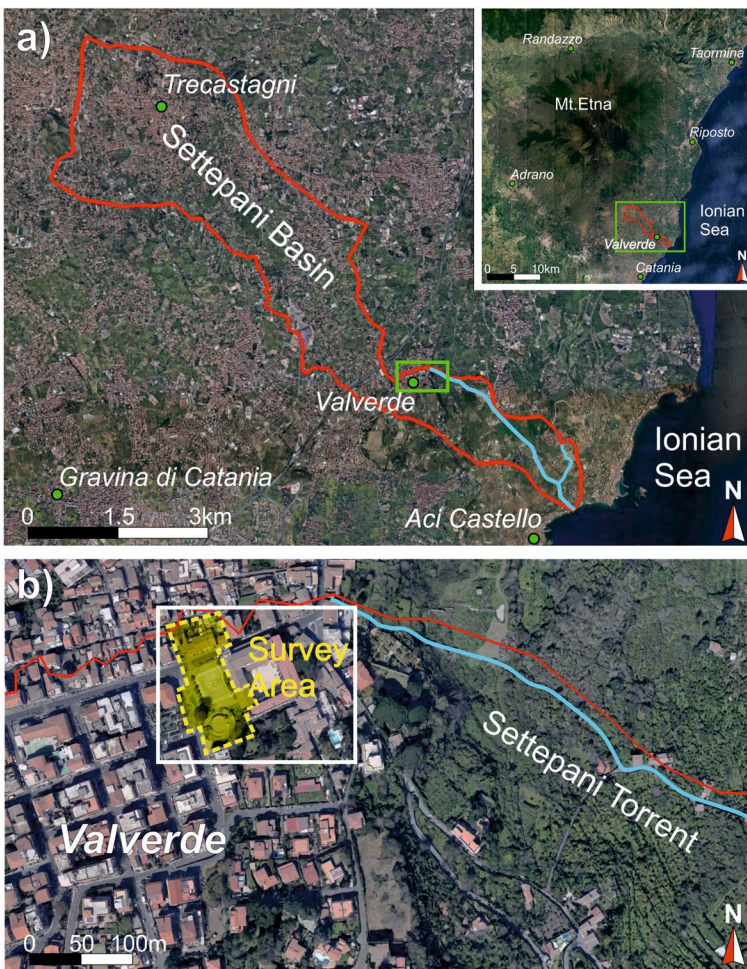
Fig. 1 **a** Location of Settepani basin, the red line point out the shape of hydrographic basin, the light blue line show the development of hydrographic network; inset upper right shows the location of Valverde municipality in the south-eastern flank of Mt. Etna; **b** position of survey area respect to Settepani torrent

From the morphological point of view, the Settepani torrent has a surface area of 14.2 km² which gradually slopes from 640 to 0 m a. s. l. Its maximum axis direction is east-southeast and it has a not well-developed hydrographic network, as can be seen from Fig. 1. This is due to the presence, especially in the western part of the catchment area, of high permeability volcanic rocks outcrops and associated groundwater flow (Romano et al. 1979; Ferrara and Pappalardo 2008). The main part of the network is 4.6 km in length and it starts few hundred metres north-east from the historical centre of Valverde. Before joining the sea this main axis collects water from a smaller affluent stream. Analyzing the lithotypes of the area it is possible to suppose that the historical centre of Valverde is developed on a paleo-riverbed (Fig. 1b).

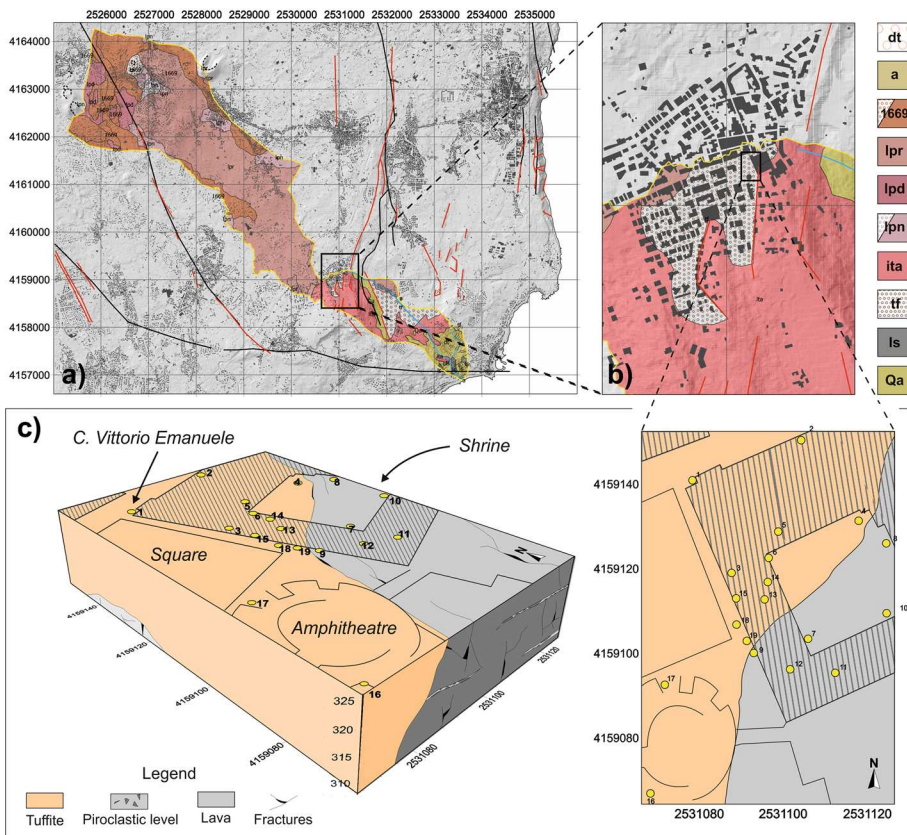
Fig. 2 a, b Geological map of Settepani Basin: dt debris, a recent alluvial deposits; 1669 lava flows and pyroclastic deposits of 1669 AD eruption, lpr-lpd-lpn lava flows and pyroclastic deposits of recent Mongibello; ita lavas from the ancient alkali centres; tf tuffites; ls basal subalkaline lavas; Qa blue-grey marly-clays; c 3D lithological model of study area subsoil, the yellow dots represent the locations of mechanical drillings

From the geological perspective (Fig. 2a, b), the catchment area of the torrent is mainly characterized by lava flows and pyroclastic fall out deposits, localized in the western side.

The 3D lithological reconstruction (Fig. 2c) obtained from the interpolation of the data relating to the 19 drillings (Fig. 3), previously carried out in the study area, shows that the subsoil of the area is characterized by the presence of tuffites in the north-west sector, the south-east sector is instead characterized by the presence of pyroclastic levels and fractured lava. A sharp boundary is observable between these two sectors, which can be linked with some tectonics elements reported in previous studies, like a fault, or related with a lava flow boundary (Romano et al. 1979; Branca et al. 2011; Barreca et al. 2013).

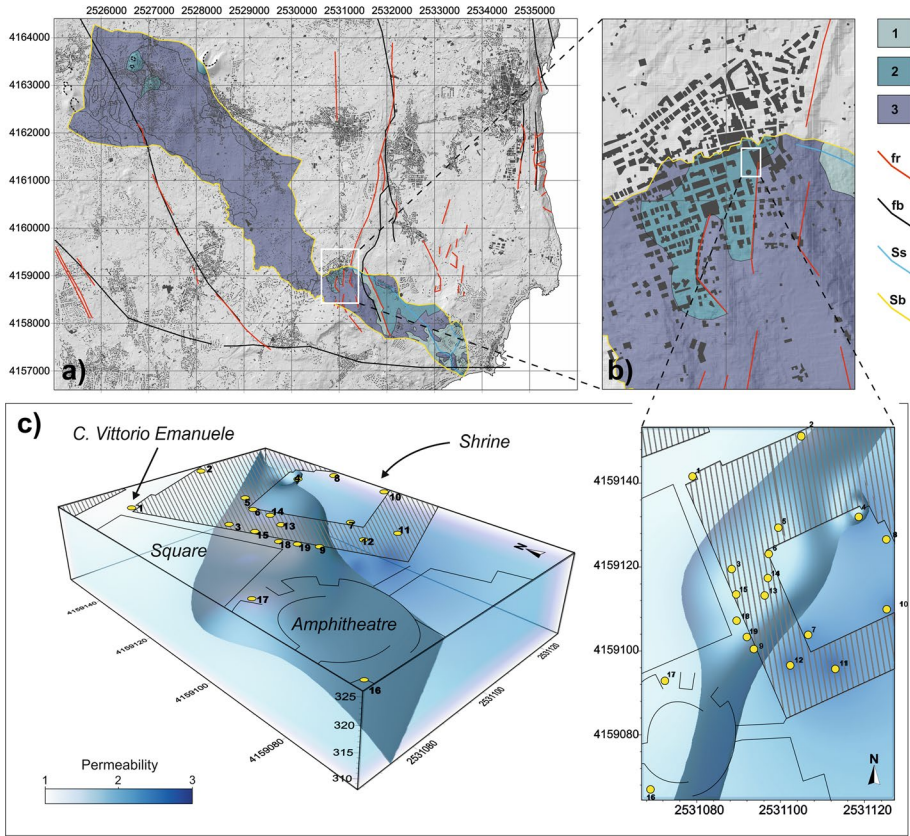
Fig. 4 **a, b** Settepani basin permeability map: **1** low, **2** middle and **3** high permeability; **fr** faults (from Romano et al., 1979), **fb** faults (from Barreca et al., 2013), **Ss** Settepani hydrographic network; **Sb** Settepani basin; **c** 3D model of study area subsoil permeability, the yellow dots represent the locations of mechanical drilling

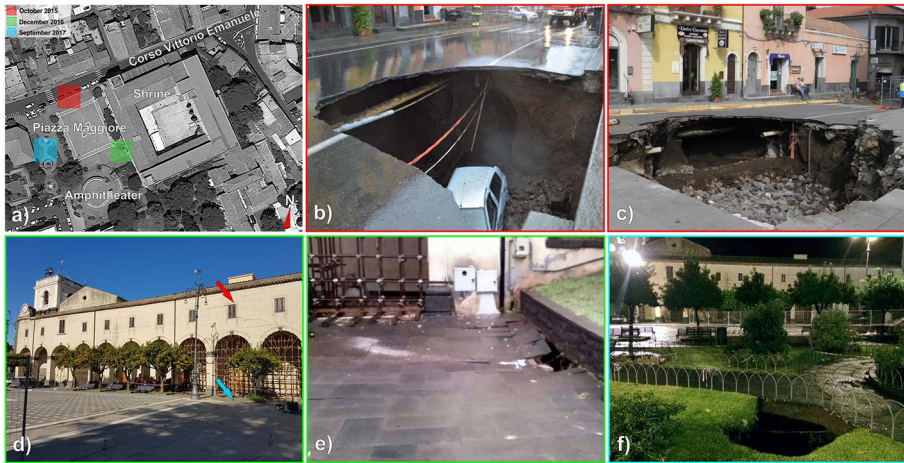
Fig. 5 **a** Location of areas where the collapse occurred; **b**, **c** photo of roadway collapse occurred in October 2015; **d**, **e** photo of subsidence happened in December 2016, the red arrow points at structural damages observed on the facade of Maria Santissima Shrine, the blue arrow indicates a soil depression observed near the pillar; **f** photo of a collapse occurred in a flowerbed in September 2017

At about 2.15 p.m. on 21/10/2015, an extensive subsidence of the road surface occurred in the historic center of the Valverde municipality, in Corso Vittorio Emanuele near to Piazza Maggiore (Fig. 5 a, b, c). This subsidence led to the formation of a chasm of about 30 m² wide and 4 m deep into which a parked car fell. Inside the chasm was observed a break in the pipeline of the white water regimantation system, noting that the consequent leak of the water had cause the leaching of the tuffites towards areas characterized by greater permeability.

In December 2016, subsidence was observed in the flooring of the southern sector of Piazza Maggiore and on the adjacent structure of the Maria Santissima di Valverde Shrine (Fig. 5a, d, e). Even in this case the disasters occurred in conjunction with a rainfall event that took place between 6 and 7 December, which affected part of eastern Sicily and in particular the eastern side of Etna. From the results obtained by the rainfall analysis, it is clear that the meteorological dynamics are similar to those found in October 2015.

Between 26 and 28 September 2017, further flooring subsidence phenomena was observed in some sectors of Piazza Maggiore and within the adjacent public green area

(Fig. 5a, f). Once again, the subsidence occurred in conjunction with short, but intense, rainfall events.

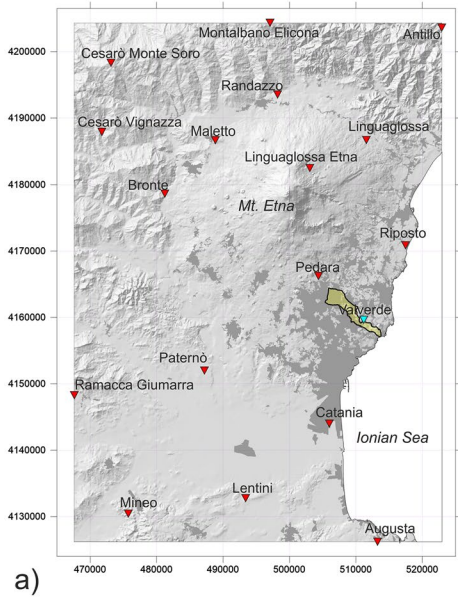
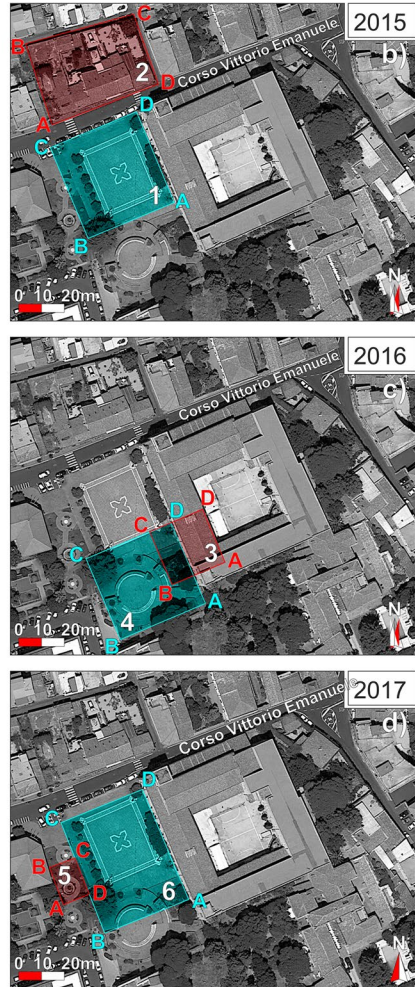
Fig. 6 a Location of rainfall stations, areas subjected to 3D ERT surveys in 2015 (b), 2016 (c), 2017 (d)

With the aim to identify the causes that led to the subsidence phenomena (Fig. 5) was carried out a rainfall analysis of the previous periods to the occurrence of such events. To obtain a rainfall analysis, in this study were considered records from 18 rainfall monitoring stations. The Sistema informativo Agrometeorologico Siciliano (Regione Sicilia—SIAS) manage 17 of these rainfall stations and one of them is owned by a private user (Fig. 6a).

The 17 SIAS stations are located in the eastern part of Sicily, forming a dense network which encloses the volcanic complex of Mt. Etna. The data from the private station were fundamental for this study for its position, inside the Valverde municipality of about 400 m to N-E from the collapsed area (Fig. 6a).

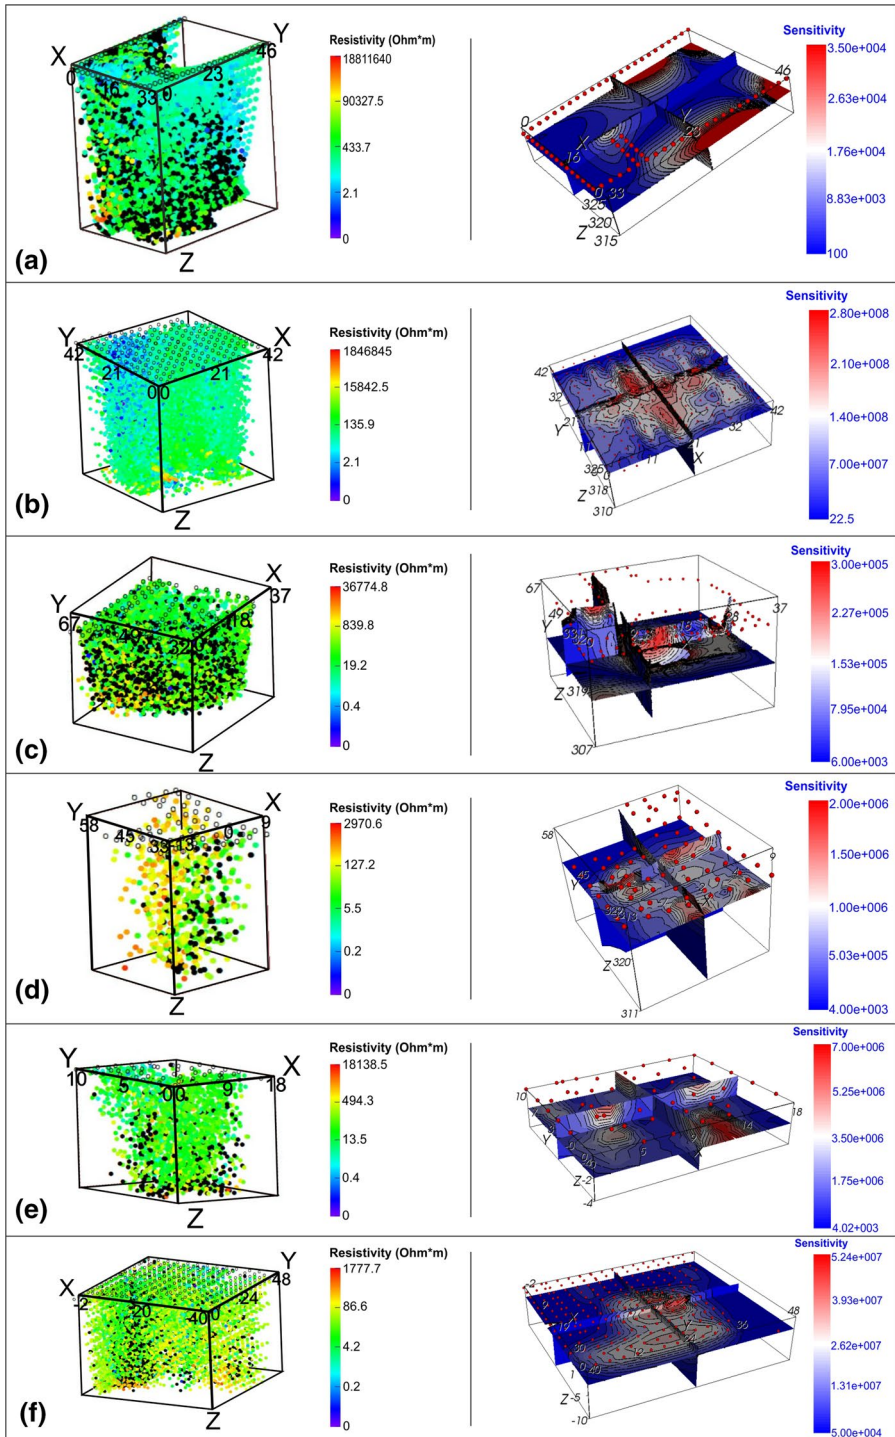
Fig. 7 3D View of the total number of apparent resistivity data measured at depth (left) and sensitivity plot (right) related to ERT surveys carried out: in 2015 around the buildings (a) and at the square (b); in 2016 at amphitheater area (c) and at the Shrine area affected by structural damages (d); in 2017 at public green area (e) and at the square (f)

The first field survey, was carried out on 22 and 23 October 2015 (Table 1). Two 3D ERT were performed using 96 electrodes arranged along a grid with regular mesh, with an interelectrode spacing of 3 m. The third ERT, performed in order to investigate the foundation subsoil of private buildings, was carried out using 72 electrodes placed around the buildings perimeter with an interelectrode spacing of 2 m.

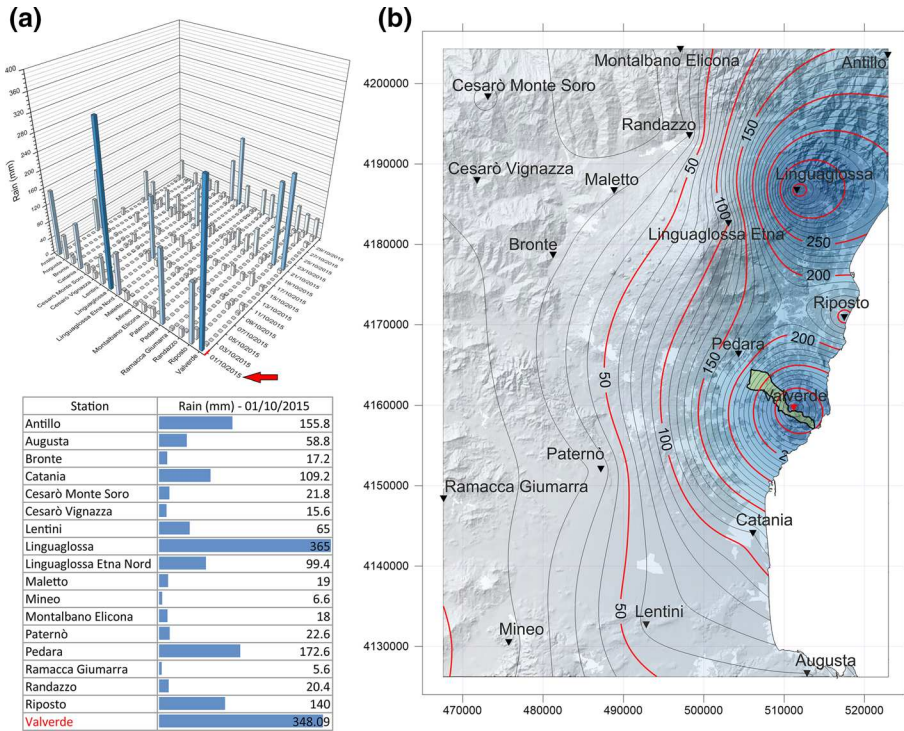
Fig. 8 **a** 3D bars graph related to October 2015 rainfall data recorded by the stations, table showing the rainfall data of October 01; **b** isohyets map obtained interpolating rainfall data of October 01 recorded by the stations

(Figs. 8, 9). The isohyets map obtained interpolating rainfall data of 1 October (Fig. 8b), show that, while on the western side the precipitations were limited and sometimes not significant, this meteorological event affected intensively the entire Etna eastern slope. This type of phenomenon, particularly frequent in Etean climate, is linked to the meeting of hot and humid currents coming from E and ESE, with the orographic barrier (Mt. Etna), which give rise to the Stau effect on the eastern side and the Fhon effect on the western one (Caccamo et al. 2017; Raffaele et al. 2020). On 1 October, the most significant rainfall was recorded at Linguaglossa and Valverde stations, respectively 365 and 348 mm/day (Fig. 8a). By the isohyets map, it can be seen that the entire basin of the Settepani stream was affected by rainfall > 200 mm/day.

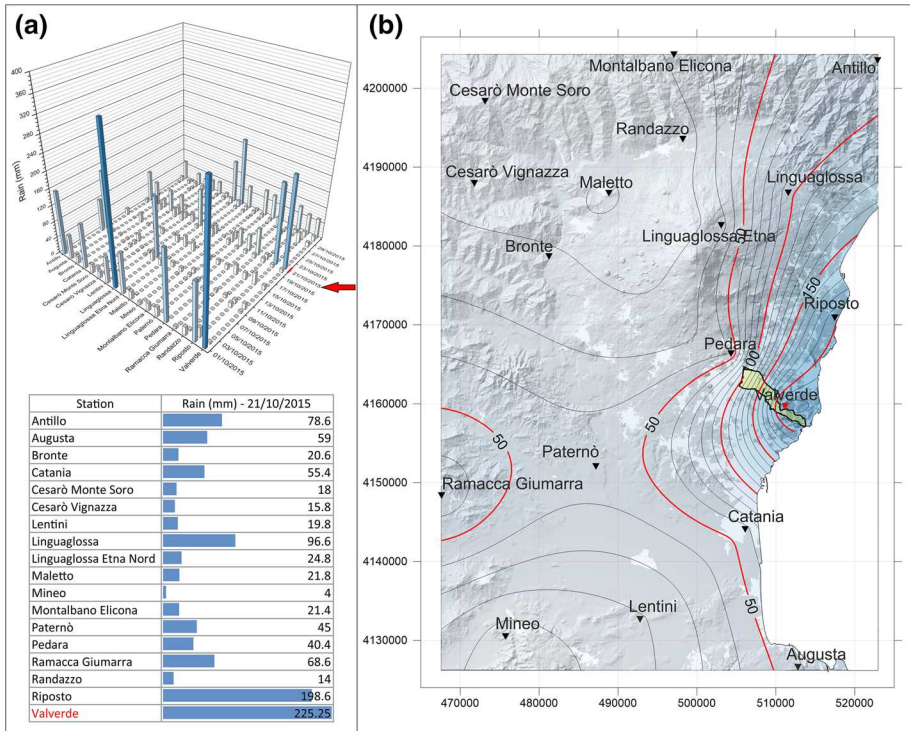
Fig. 9 **a** 3D bars graph related to October 2015 rainfall data recorded by the stations, table showing the rainfall data of October 21; **b** isohyets map obtained interpolating rainfall data of October 21, recorded by the stations

In order to determine the causes of the subsidence, in a first phase, an analysis of rainfall data relative to October 2015 was performed. Observing the data relating to the various Etna rainfall stations, it is immediately evident that two more intense rain events, which occurred respectively 1 and 21 October, involved the eastern side of Etna

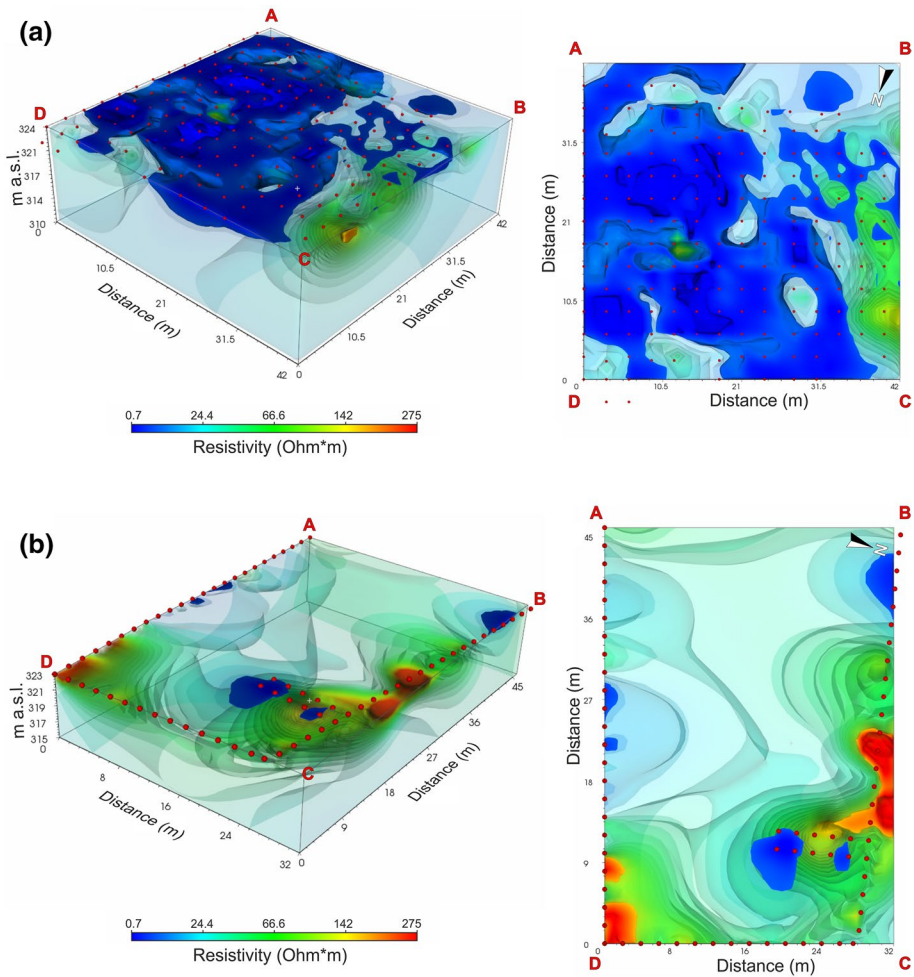
Fig. 10 a 3D model related to the ERT surveys performed at the square (see Fig. 6b-1); b 3D model related to ERT survey carried out around the buildings (see Fig. 6b-2)

The data obtained from the two tomographies carried out on the square were jointly inverted in order to reconstruct a 3D model of the resistivity distribution in the subsurface of the entire survey area (Figs. 6b-1, 10a). The model obtained shows the presence of a large low-resistive volume ($\sim 0.7\text{--}10 \Omega \cdot \text{m}$), which can be correlated to the presence of humid tuffites, extending approximately in NNW-SSE direction. The depth of this low-resistive volume varies from about 8.5 m in the south area of the square and wear thin gradually, away radially from this point.

The resistivity model obtained by the 3D ERT performed around the buildings (Figs. 6b-2, 10b) show average resistivity values, which can be correlated to the lithotypes present in the subsoil. Small low-resistivity volumes ($\sim 0.7\text{--}10 \Omega \cdot \text{m}$), with reduced thickness, equal to about 0.5 m, are observed near Corso Vittorio Emanuele. This area, close to the one where the chasm occurred, could be related to the water circulation below the road surface caused by the rupture of the pipeline. Furthermore, there are two other low-resistive zones characterized by a thickness between 0.5 and 1 m. The first, located at a manhole inside the building's courtyard, could be due to the disposal of white water from the structure. The second low-resistive zone is located in correspondence with two small masonry buildings, with an apparent poorly waterproofed base, that could favour the conveyance and infiltration of water. Thus allowing to exclude the hypothesis that this area may be linked to the water circulation that caused the road surface subsidence.

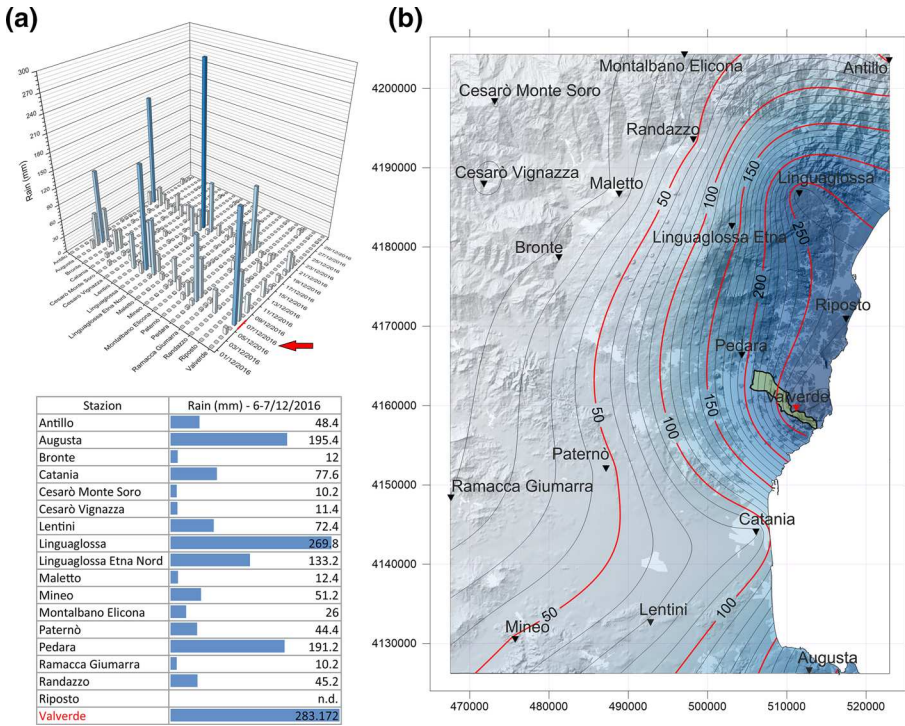
Fig. 11 **a** 3D bars graph related to December 2016 rainfall data recorded by the stations, table showing the cumulated rain values of December 06–07; **b** isohyets map obtained interpolating cumulated rain values of December 06–07, recorded by the stations

The data relating to the rainfall stations, show that the greatest values for the cumulated rainfall were recorded at Valverde (283.17 mm) and Linguaglossa (269.8 mm)

stations (Fig. 11a). From the isohyets map obtained adding up the daily rainfall relating to 6 and 7 December (Fig. 11b), it is possible to note how the maximum rainfall, involves the Etna eastern sector, affected mainly the coastal and foothill areas. In particular, the Settepani basin is characterized by a rainfall rate of about ~210–290 mm.

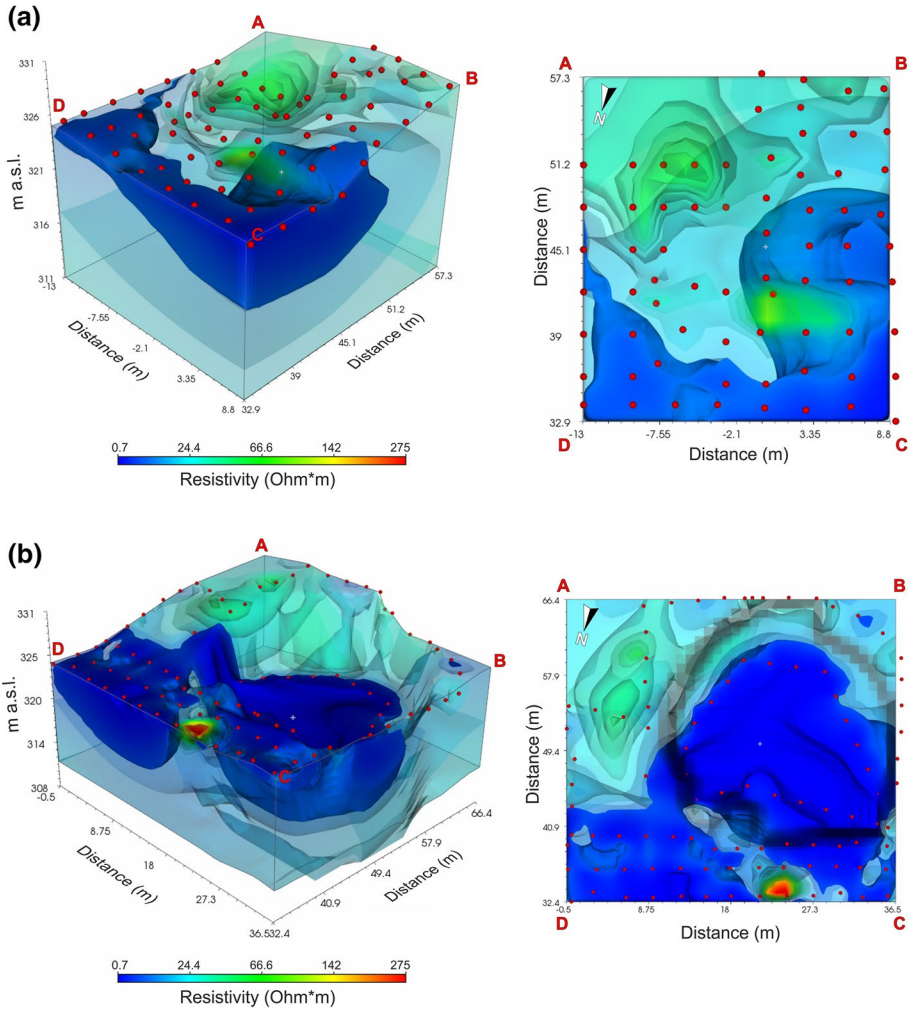
Fig. 12 **a** 3D model related to the ERT survey performed at the Shrine area affected by structural damages (see Fig. 6c-3); **b** 3D model related to ERT survey carried out at amphitheater area (see Fig. 6c-4)

The electroresistive models obtained from the surveys elaboration (Fig. 12a, b) show a low-resistive area (~0.7–15 $\Omega \cdot m$) correlated to the presence of humid tuffites, which affects the NE sector for almost all amphitheatre area. This volume, which reaches a depth of about 14 m, is not confined only in the model northern part, next to the square. This low-resistive area, characterized by resistivity values comparable to those observed in the

tomographies carried out following the 2015 event, and in agreement with them for geometric continuity, confirms the hypotheses made following the surveys previously carried out on the square, which showed an extension towards south of the low-resistive block. Even in this case, the geometry of the low-resistive volume is indicative of a subsurface water flow in lavas direction, which are characterized by higher permeability values.

In the NW sector of the investigated area, near a maintenance room, is present a high-resistive zone. Another area characterized by medium–high resistivity values is observable in the SE direction. In this second zone, mechanical drillings revealed the presence of fractured lavas, the resistivity values identified are therefore compatible with the lithotypes present.

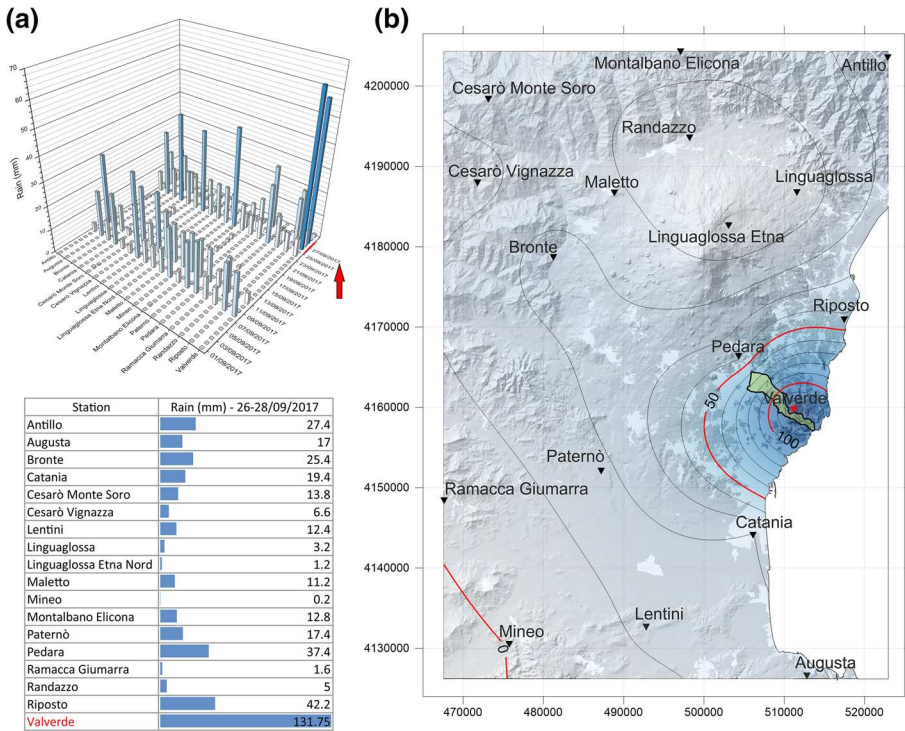
Fig. 13 **a** 3D bars graph related to September 2017 rainfall data recorded by the stations, table showing the cumulated rain values of September 26–27–28; **b** isohyets map obtained interpolating cumulated rain values of September 26–27–28, recorded by the stations

The graphical representations obtained by the analysis of rainfall data show clearly that the Valverde rainfall station, during the three days, have accumulated significantly higher rainfall rates than the other Etna stations (Fig. 13a). Therefore, in this case the meteorological dynamics that affected the area differ from those observed in the previous cases, as it is a particularly localized event, which does not extensively affect the eastern Etna side (Fig. 13b).

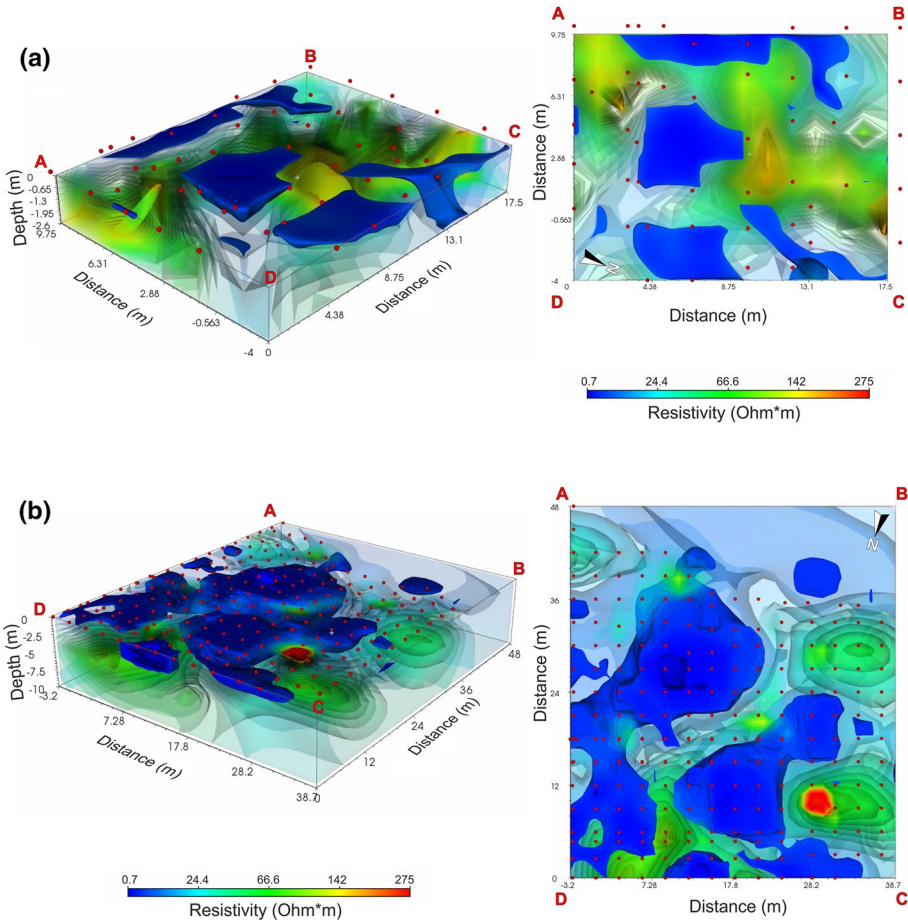
Fig. 14 a 3D model related to the ERT survey performed at public green area (see Fig. 6d-5); b 3D model related to ERT surveys carried out at the square (see Fig. 6d-6)

The 3D electrical tomography performed in the public green area (Figs. 6d-5, 14a) showed a random distribution of low resistive and high resistive areas. Therefore, a sub-horizontal water flow is not evident, but instead the water tends to disperse vertically into the subsoil due to slow infiltration. The presence of several defined high-resistance areas indicates that there are zones that are not very compact or even the presence of voids, probably formed due to the erosive action of the waters that tend to infiltrate downwards. In the central area of the model, in correspondence to a public fountain, there is a defined

low-resistive volume approximately 1.5 m thick, probably due to the dispersion of water in the subsoil. Another low-resistive volume that needs to be attention is located to the NE. This laterally confined volume reaches up to the maximum investigated depth, about 2.60 m, so it is possible to suppose that this area may be affected in the future by a phenomenon know as hydrodynamic instability or siphoning. This phenomenon occurs when the intergranular forces are cancelled, and consequently the ground resistance is cancelled too, thus the solid particles can be transported from moving water, giving rise to a progressive erosion phenomenon that leads to the collapse of the soil structure.

The 3D electrical tomographies carried out on the square (Figs. 6d-6, 14b) show a large low-resistive area that geometrically overlaps that found in the 3D electrical tomography carried out in 2015. Despite a geometric similarity, it is evident that the low resistive area is less extensive both laterally, both in depth. Laterally confined, apart from some small area on the eastern side, in depth it extends up to a maximum of 7.4 m. The presence of a less extensive low-resistive volume indicates a lower water circulation in the subsoil, partly linked to the lower rate of rainfall and partly to the numerous interventions carried out in the area in previous years, in order to restore the white water regimentation system and mitigate subsurface subsidence phenomena.

In order to restablising the condition of stability and continuity in the ground, following the subsidence phenomena occurred in September 2017, a total filling of cavities through the laying of granular material and concrete casting were performed.

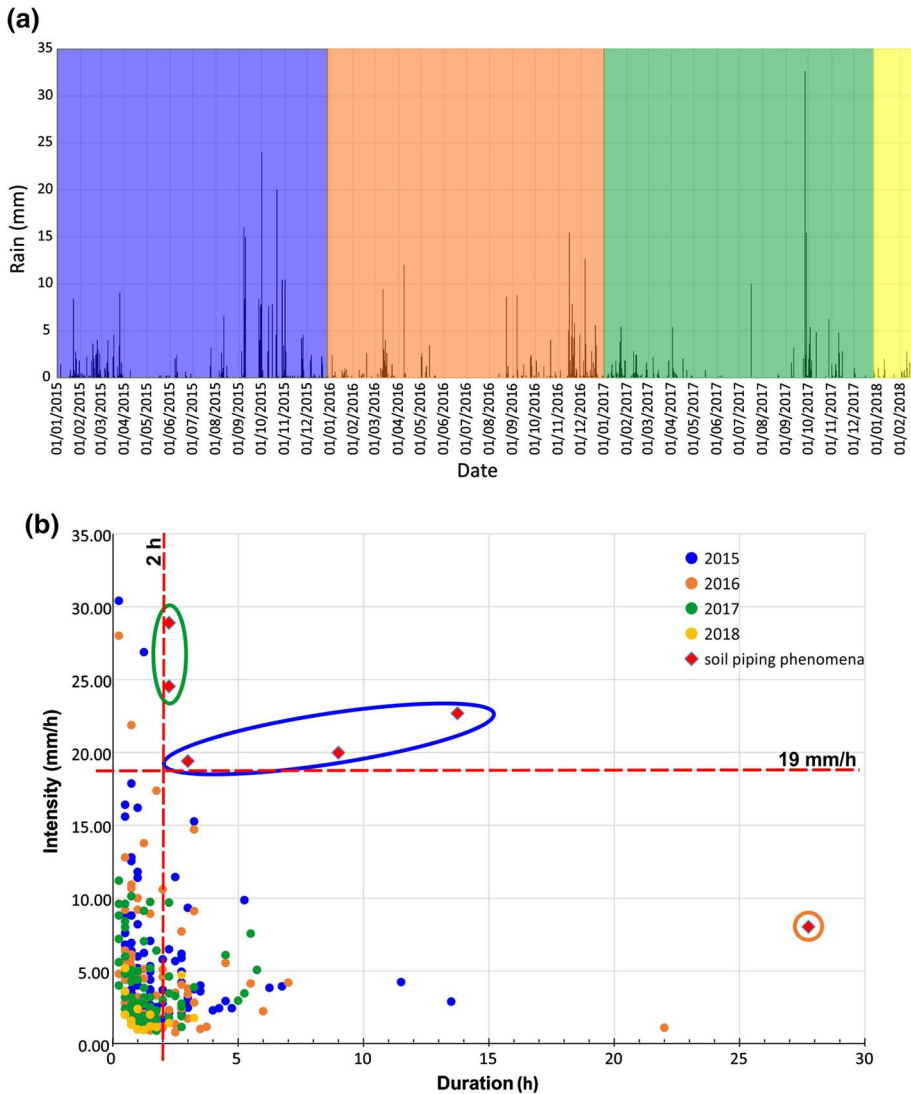
The available rainfall data from the private station were further analysed in order to obtain the threshold values for soil piping phenomena in the study area. All the rainfall events occurred between January 2015 and February 2018 were examined (Fig. 14a) selecting only those characterized by rainfall depth greater than 1 mm. For each event, the rainfall intensity was calculated and subsequently these data have been plotted, with respect to duration, on a scatter graph (Fig. 14b).

Fig. 15 a Bars graph related to rainfall data recorded by Valverde station, between January 2015 and February 2018; b scatter graph, of the rainfall intensity related to the analysis of 300 rainfall events characterized by a rainfall depth greater than 1 mm, the dashed red lines show the threshold values for soil piping phenomena identified for the studied area
