## CHARACTERIZATION OF DECAY IN THE WOODEN ROOF OF THE S. AGATA CHURCH OF RAGUSA IBLA (SOUTHEASTERN SICILY) BY MEANS OF SONIC TOMOGRAPHY AND RESISTOGRAPH PENETRATION TESTS

**KEY WORDS:** wood, sonic tomography, penetration test, S. Agata Church of Ragusa Ibla

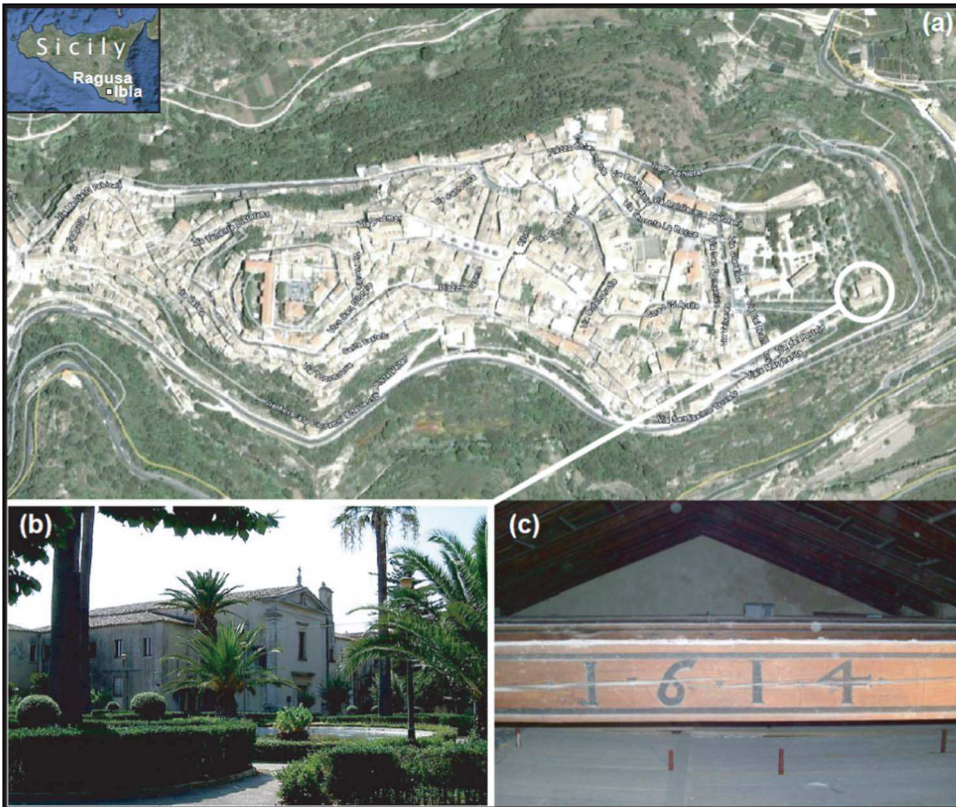
**Figure 1.** Photographs of (a) aerial view of the historical village of Ragusa Ibla, and (b) location of the S. Agata Church; (c) the date 1614 is carved into one of the roof trusses, probably referring to its construction (color figure available online).

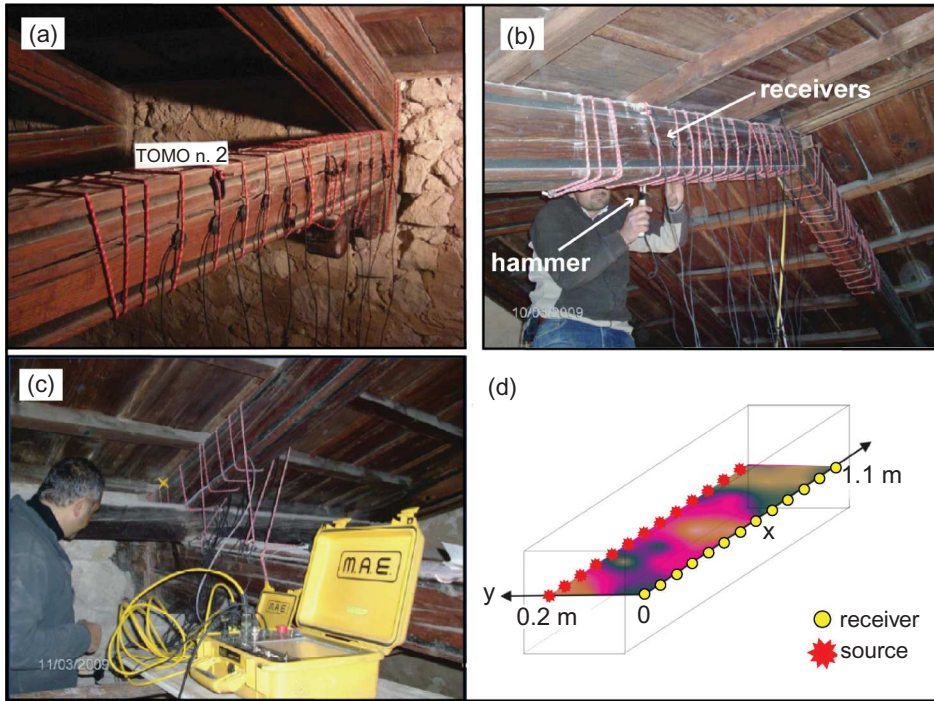
**Figure 2.** Photographs of the sonic tomography equipment along the chord (a) and the rafters (b, c); (d) scheme of the direct transmission configuration used in this survey (color figure available online).

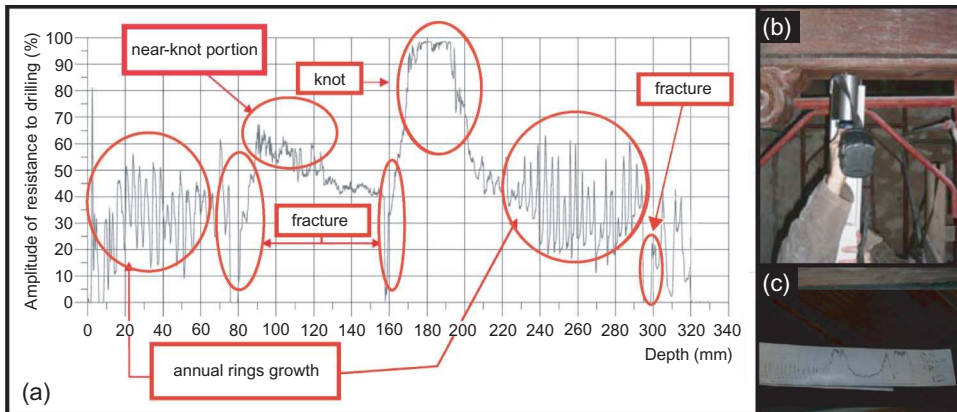
**Figure 3.** (a) Chart of example profile of resistance to drilling and interpretation of the density behavior; (b) photograph of the penetration test equipment; (c) printout of a resistogram obtained in this survey (color figure available online).
